**300 Bloor Street West LP**

Re: 300 Bloor St West (Ward 20)

**Arborist Report – Construction/Tree Protection**

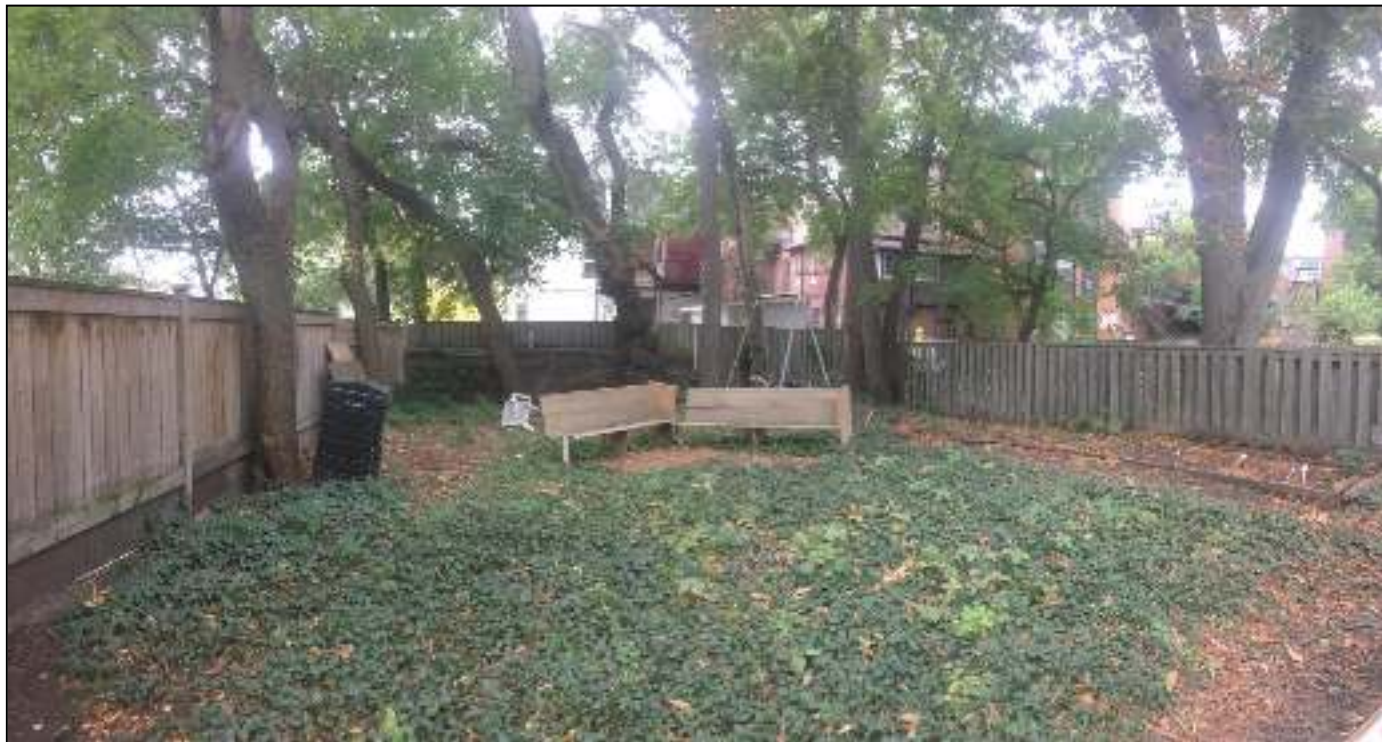
**Trees #9 to 14** are located on private property in the backyard of 478 Huron Street. The work associated with the proposed landscaping overlaps each specimen. Given they are mostly in poor condition, their removal is acceptable as it will allow for planting of new trees. Enough growing space must be allocated on the landscaping plan to accept some of the replacement trees with enough soil volume.

**Photo 1:** Trees 6 – 15, located within the backyards of 478 Huron Street and 480 Huron Street.

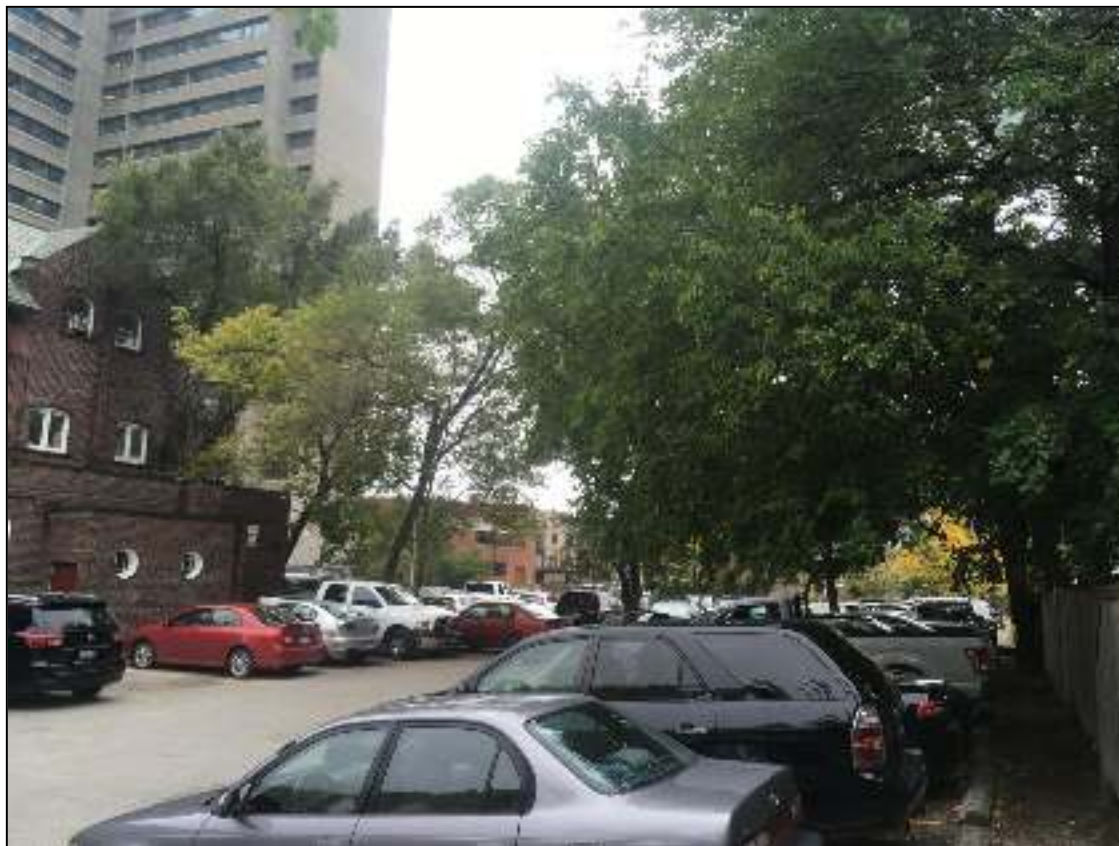
**Photo 2:** Alternate angle of trees along the property boundary between 478 Huron St and 300 Bloor Street West, and trees.

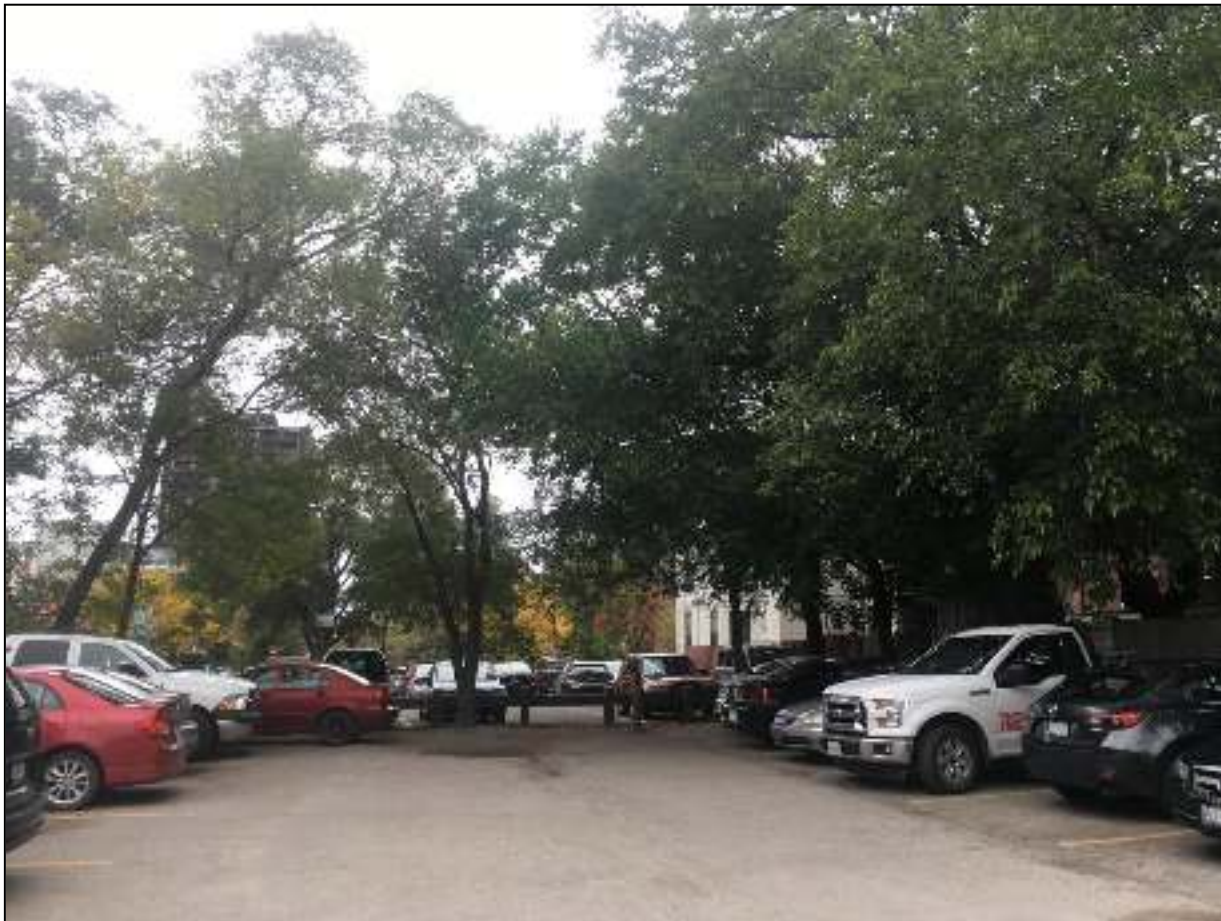
**Trees #6 – 8** are located on private property in the backyard of 478 Huron Street. The excavation associated with the proposed parking area overlaps each tree, therefore they must be removed to facilitate the proposed work.

Photo 3: (From right to left) Trees 6 – 8, and 16 – 21.

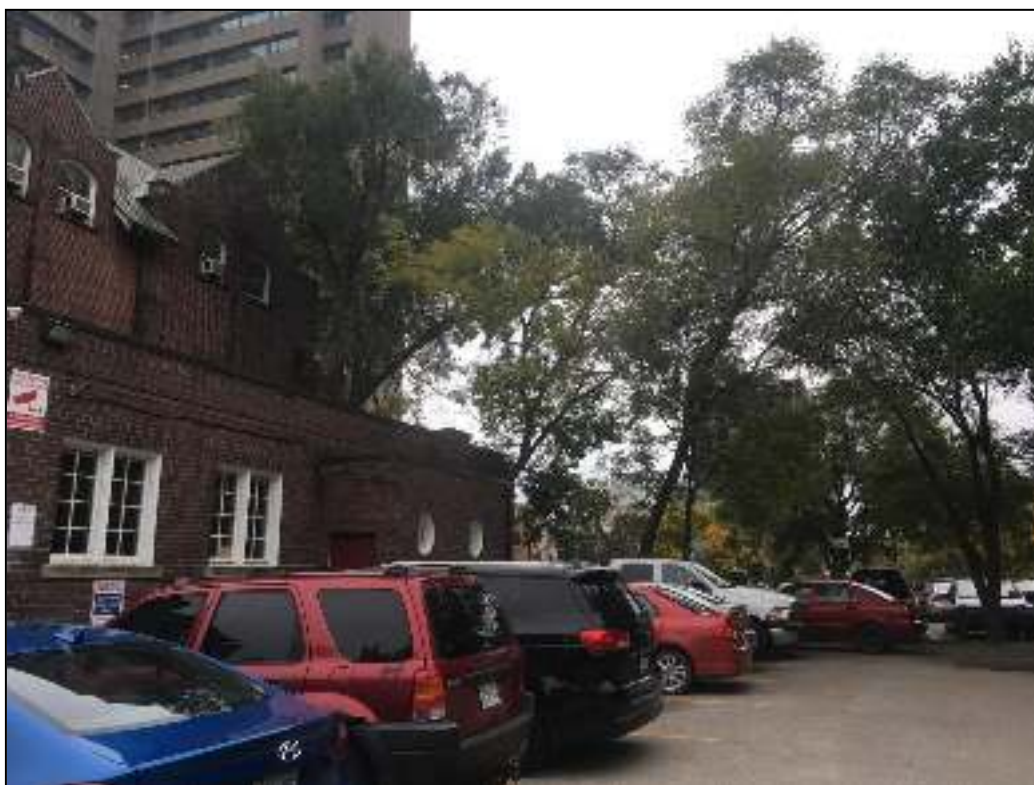
**Trees #17, 21, 22, and 24** are located on private property, along the east property line of 9 Madison Ave. The owners of that property are developing their own property and removing those trees during their work.

Photo 4: Trees 24, 23, 21, 20, and 19.

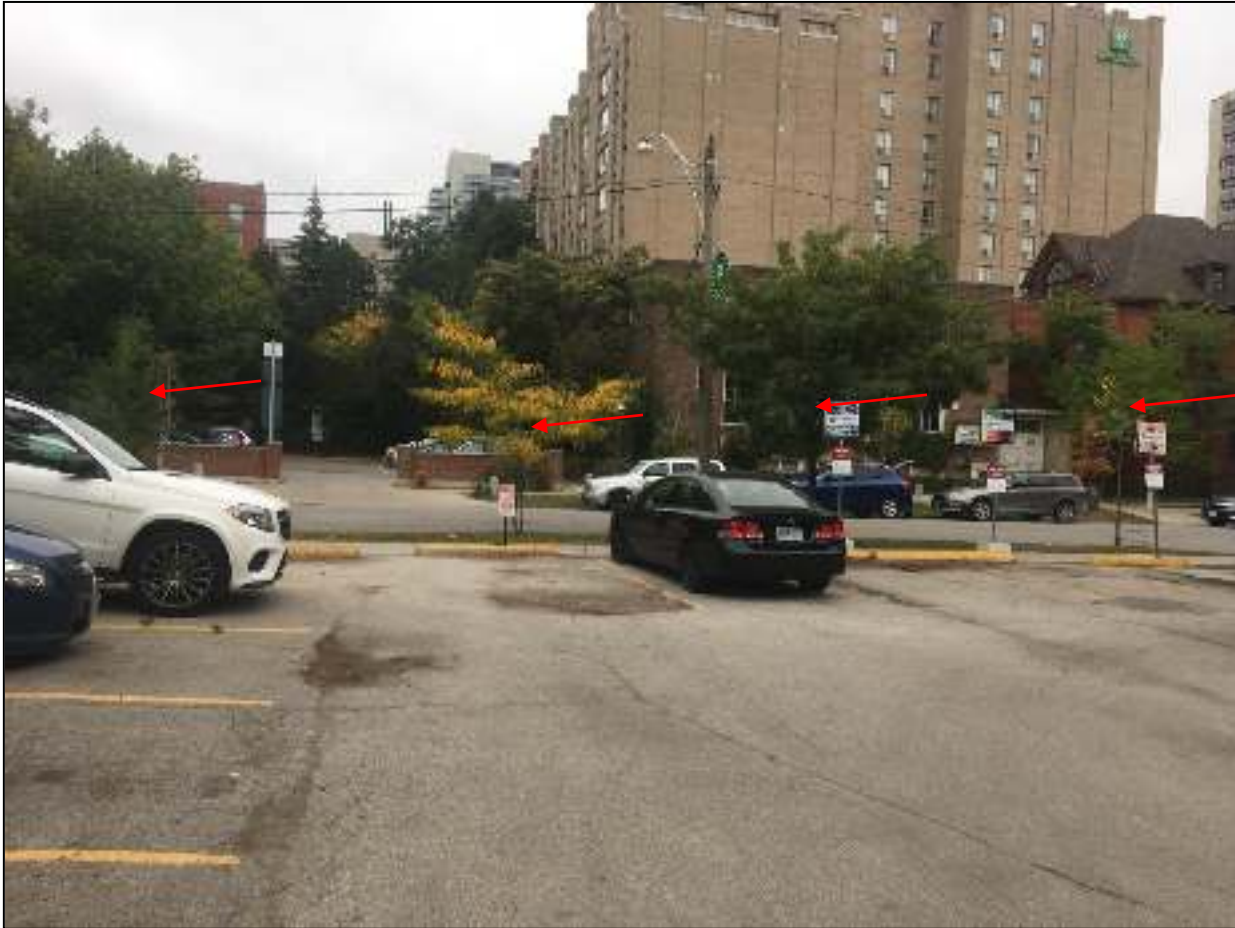
**Trees #1 – 3** are located on City property along the street boulevard of Huron Street. The subject trees are located within the footprint of the new soil cells, and require permits for removal.

**Tree #4** is located on City property along the street boulevard of Huron Street. The subject tree is located within the footprint of the new driveway, and requires a permit for removal.

Photo 5: Trees 4, 3, 2, and 1.

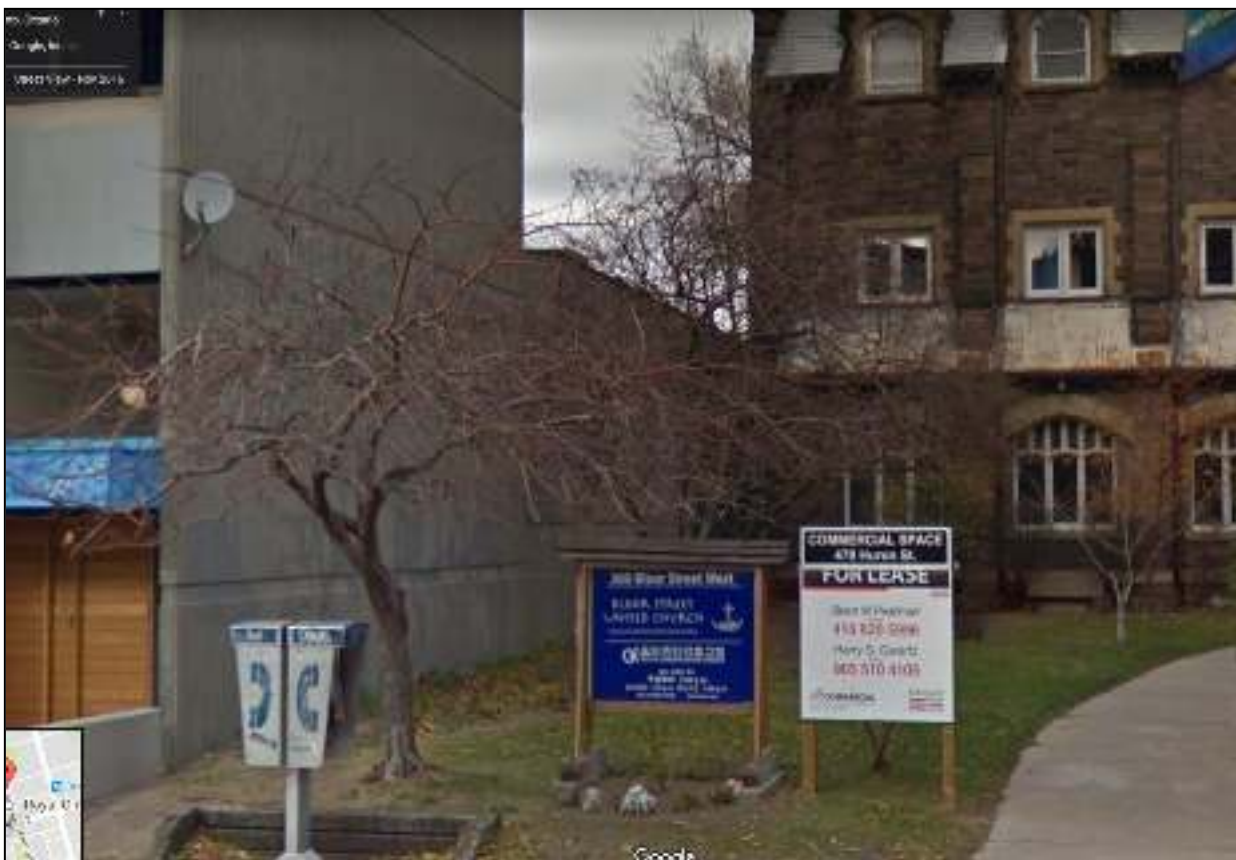
24A	Crabapple	<i>Malus sp.</i>	Good	Good	0	~25	1.8	A healthy specimen.	Tree is not protected under the Private Tree Bylaw.
24B	Crabapple	<i>Malus sp.</i>	Good	Good	0	~25	1.8	A healthy specimen.	Tree is not protected under the Private Tree Bylaw.
24C	Ash	<i>Fraxinus sp.</i>	Good	Good	1	~20	1.8	A healthy specimen.	Tree is not protected under the Private Tree Bylaw.
24D	Ash	<i>Fraxinus sp.</i>	Good	fair	1	~20	1.8	Tree grows close to existing church.	Tree is not protected under the Private Tree Bylaw.

Photo 6: Trees 24A – 24D located on 300 Bloor Street West. Image taken from Google Maps (November 2016).
